BELL HELICOPTER TEXTRON FORT WORTH TEX
HELICOPTER OBSTACLE STRIKE TOLERANCE CONCEPTS ANALYSIS.(U)

HELICOPTER OBSTACLE STRIKE TOLERANCE
CONCEPTS ANALYSIS

Bharat P. Gupta
Bell Helicopter Textron
P.O. Box 482
Fort Worth, Texas 76101

Final Report for Period September 1977 - June 1978

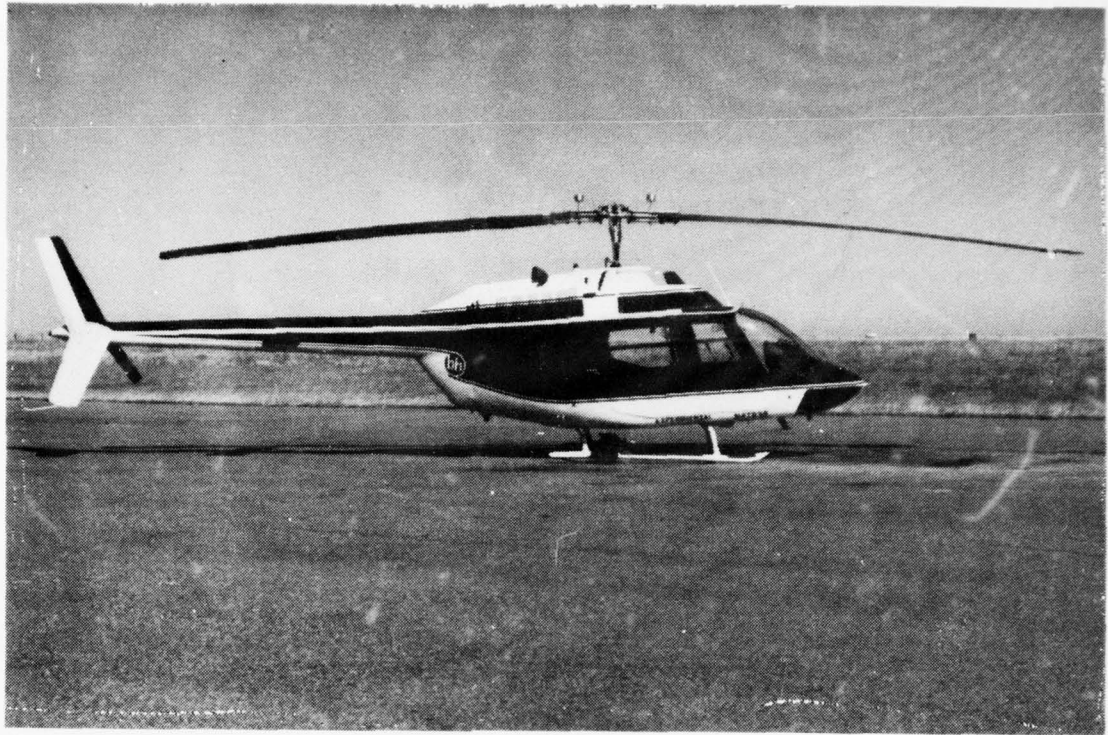
Figure 11. High Inertia Rotor, 206-Experimental Aircraft

An experimental high inertia rotor system was developed and tested on the Model 206 (see Figure 11). The rotor blades were modified to accept tungsten tip weights (Figure 12), and a Bell experimental Model 640 hub was used. (This was an elastomeric hub design, which was stronger than the standard hub.) Tip weight was varied from 11.5 pounds to 55.0 pounds, and a weight of 41 pounds was judged to give the best overall performance. The total rotor inertia in this configuration was 172 percent of standard inertia. For a Model UH-1, the same percentage increase in rotor inertia would amount to 135 pounds of additional rotor weight (90 pounds would be the tip weight, and 45 pounds would be the beef-up of the hub structure needed to carry higher centrifugal force).

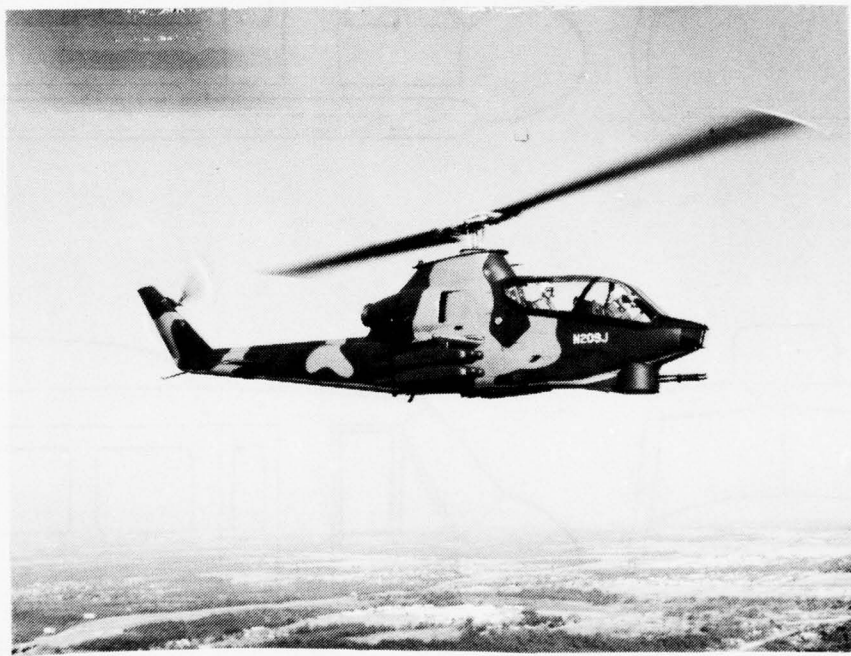
Figure 21. Flight Test of Retractable Skid Landing Gear on AH-1G

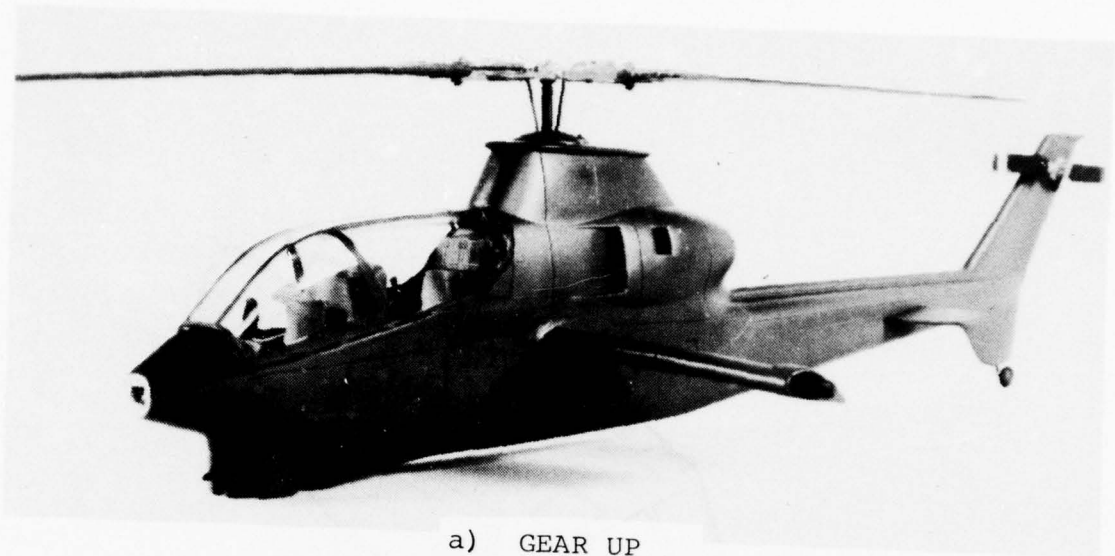
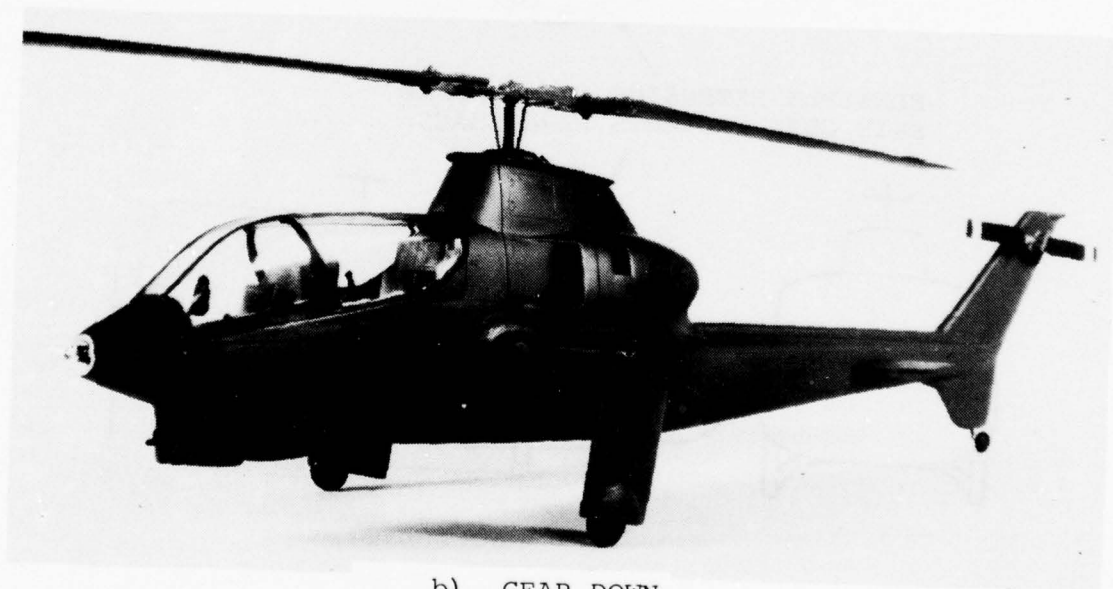
a) GEAR UP

b) GEAR DOWN

Figure 25. Deflector Shield on Wheeled Landing Gear (Shown on Model AH-1)
